Re: Westbank Asbestos Removal Project

GILBERT ENGINEERING AND INSPECTION SERVICES  
405 GRETNA BLVD. - SUITE 209  
GRETNA, LOUISIANA, 70053  
(504) 365-0175

## STRUCTURAL ENGINEERING REPORT

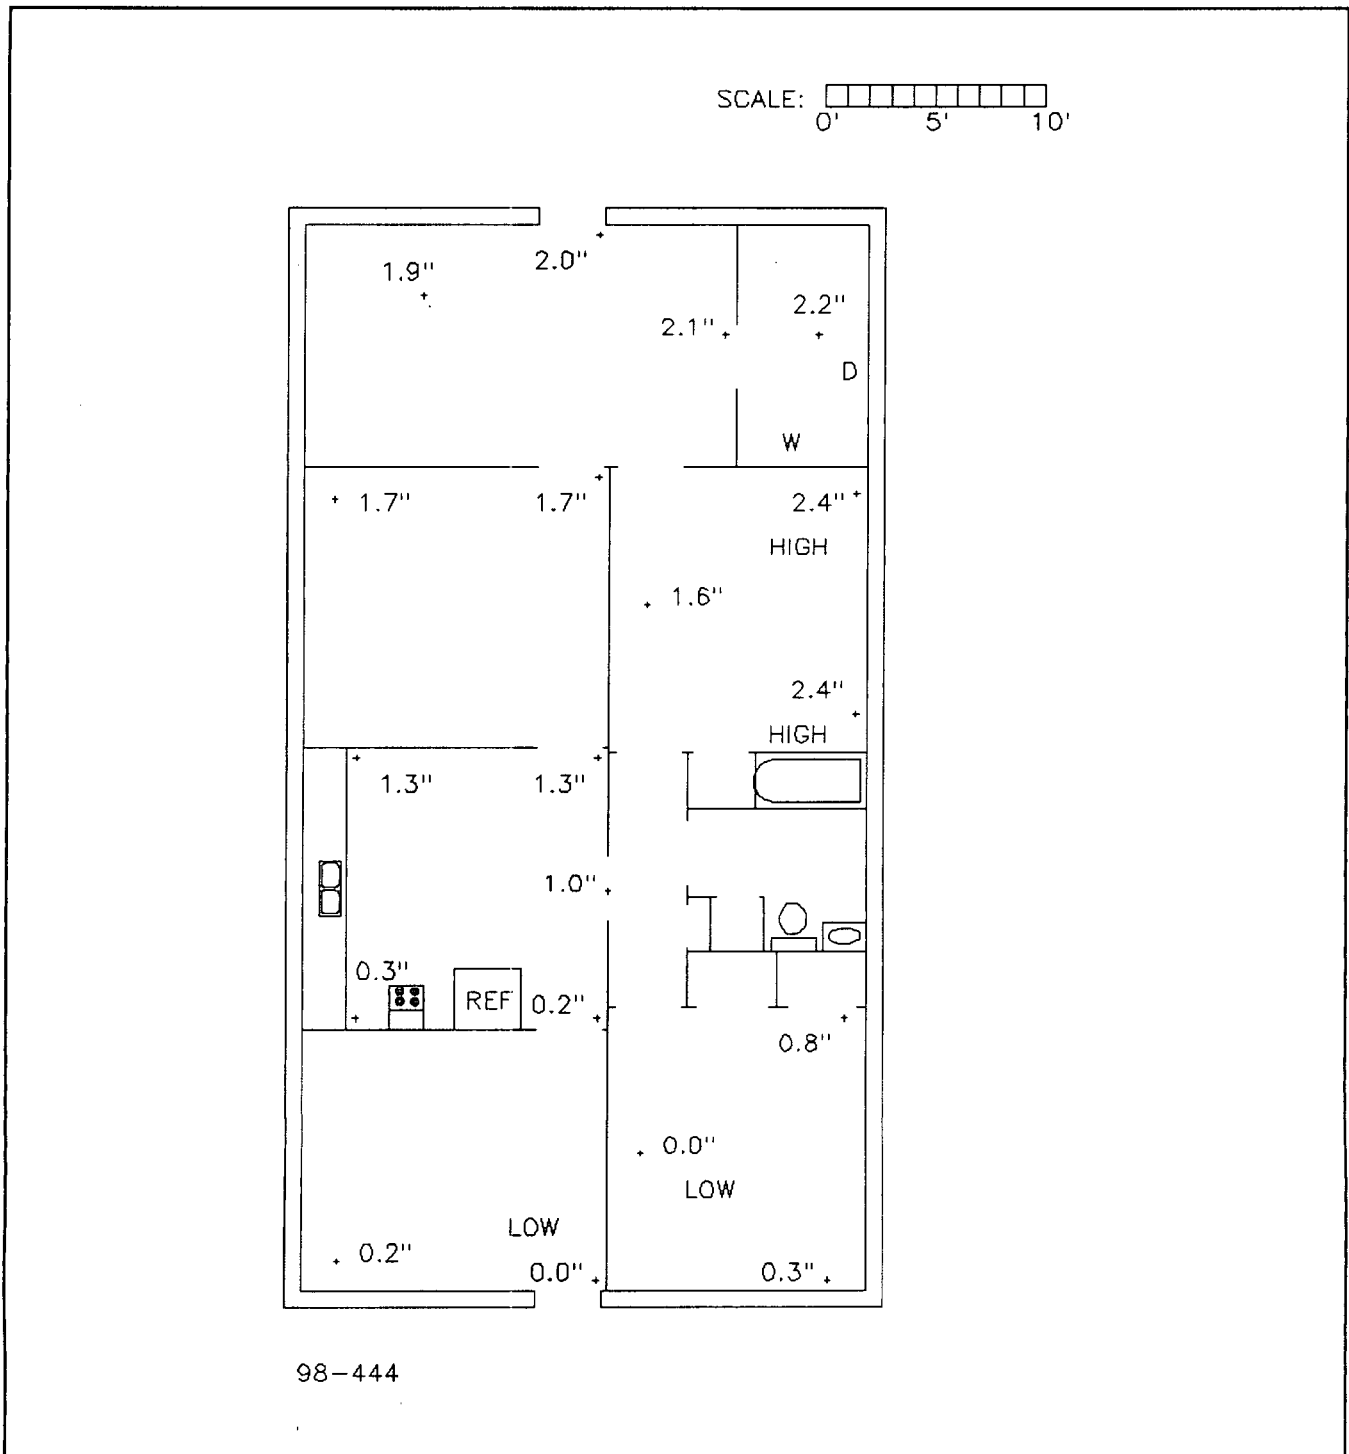
**Figure 1 - Relative Elevations**

Relative elevations<sup>2</sup> were taken and are presented in Figures 1 and 2. The relative elevations, which are discussed in the Appendix, show the elevation in inches of selected points of the foundation relative to the lowest point measured (i.e. the elevation at the lowest point is set equal to 0"). Figure 1 shows the value and location of the relative elevations. Figure 2 is a plot of the relative elevations from front to rear.

The foundation slopes downward from the rear to the front. The high points are along the right side. The low points are near the center at the front of the house.

The total differential is 2.4". Approximately 63% of all pier and beam foundations in the Greater New Orleans area have differentials of 2.4" or more. The average differential for all foundations in the New Orleans area, south of the lake but excluding the River Parishes, is 3.17".<sup>3</sup> The average for pier and beam foundations is 3.45". The average differential in this portion of the Greater New Orleans area (MLS areas 041-043) is 2.47".

The slope between the closest high and low points is 0.120" per foot or 1 3/16" in 10'; however, the slope changes significantly from front to rear as shown in Figure 2. The average slope measured during routine structural engineering inspections is 0.085" per foot or 7/8" in 10'. The average slope in this area is 0.073" per foot or 3/4" in 10'. Evaluation and comparison of the differential settlement of foundations should include not only the total differential, but should also consider the distance between the high and low points which is reflected in the slope data. The Appendix discusses the comparison of total differential and slopes in more detail.

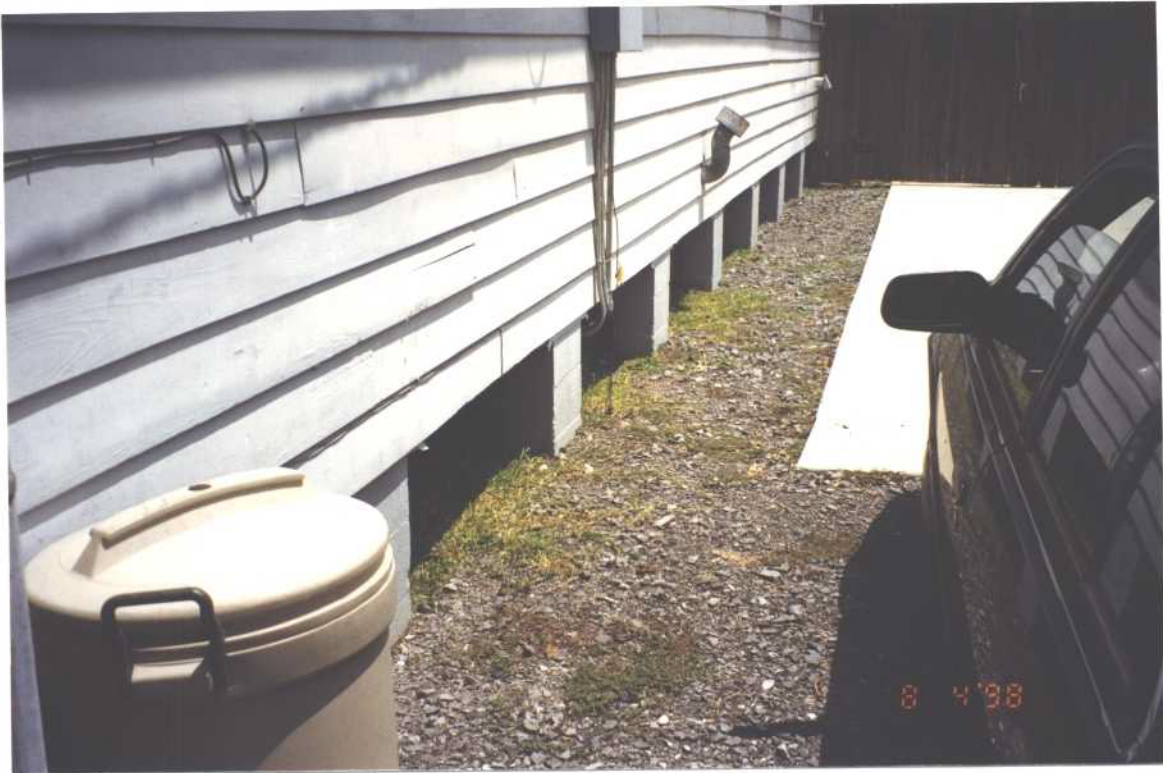
RIGHT SIDE PIERS

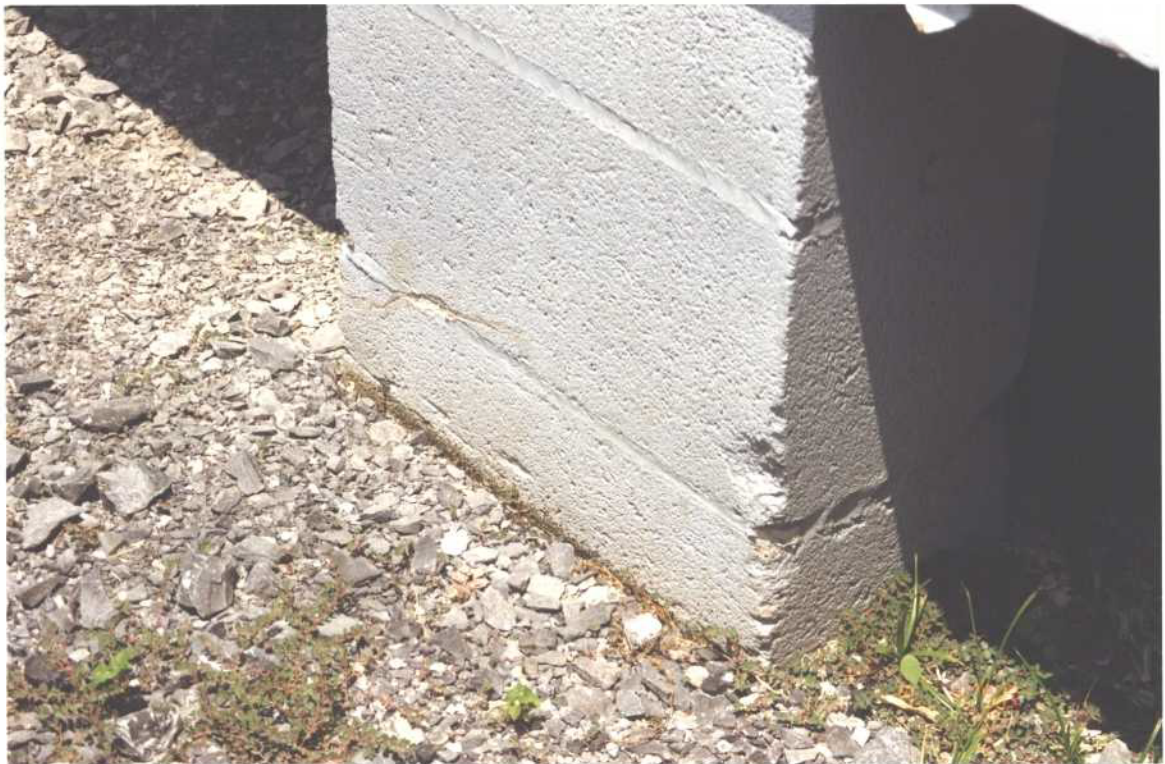
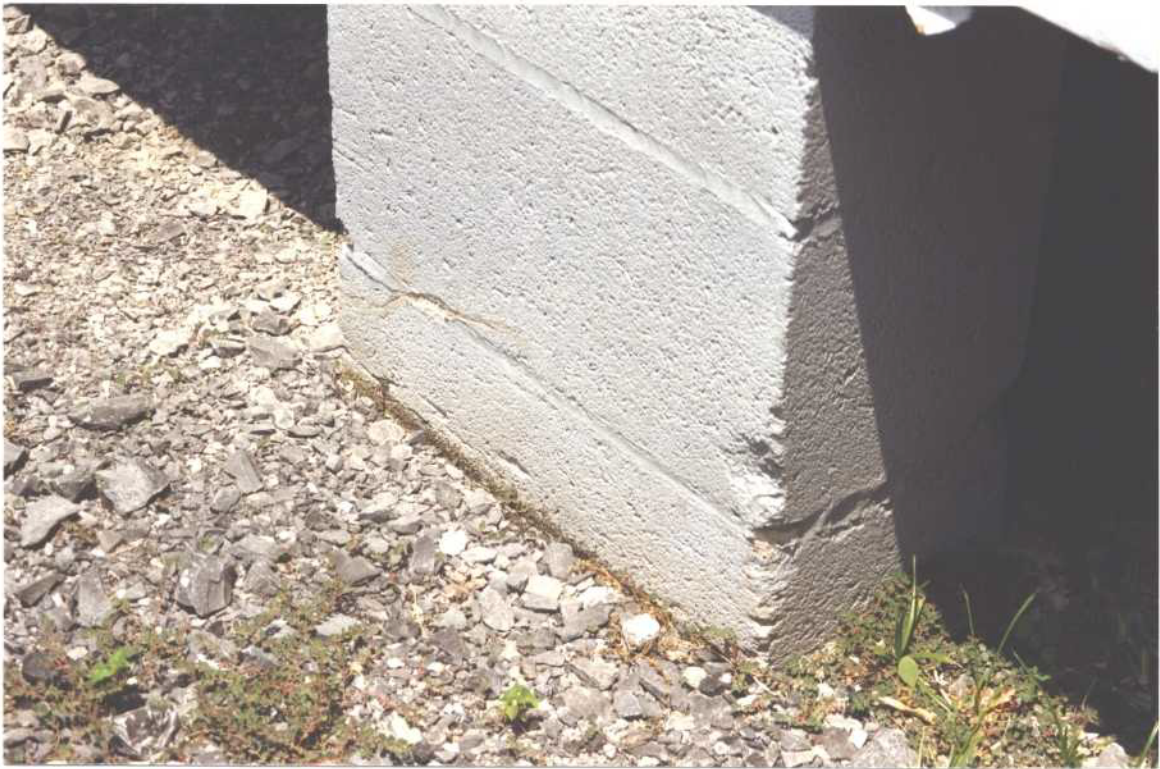
The visible portion of the foundation and framing appears in generally satisfactory condition. There are minor chips in the block piers along the right side. The chips have occurred since the piers were

CHIPPING OF RIGHT PIER

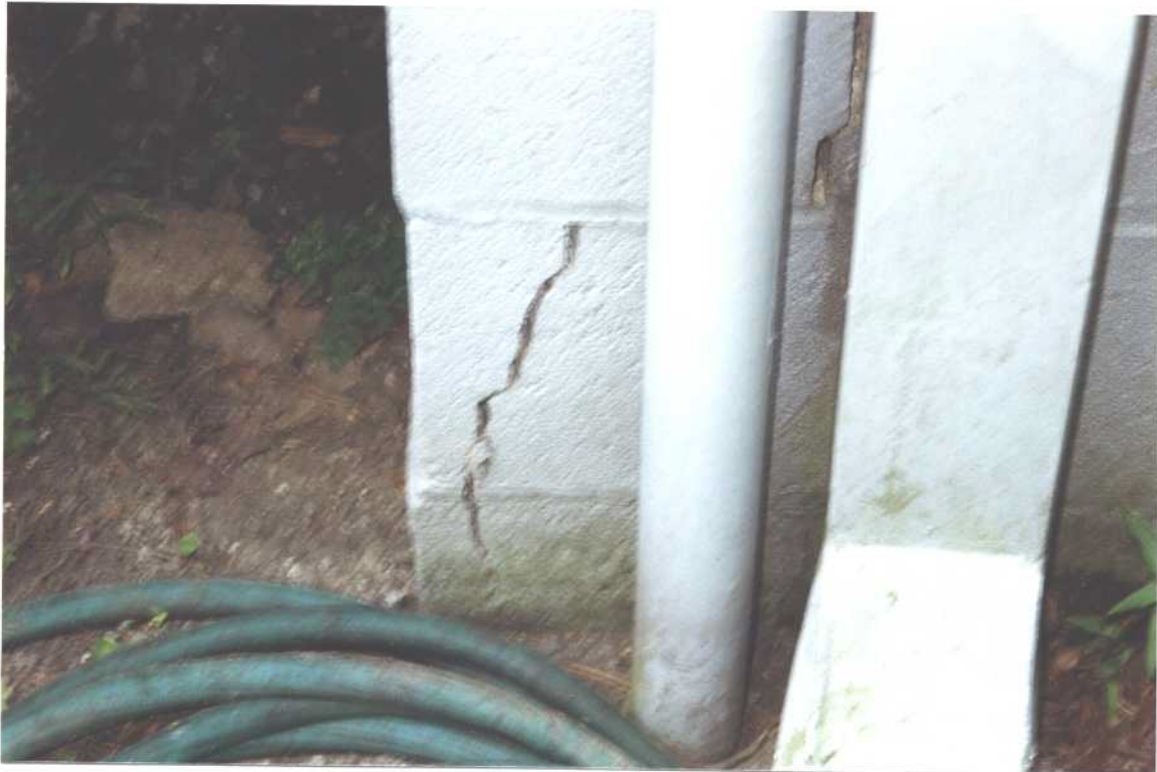
There is some cracking of the concrete block piers, particularly along the left side and in the concrete block chain wall across the front. There was paint in several of the cracks, indicating the cracks occurred prior to the concrete blocks being painted. There is some relative movement between the concrete block front porch and the house.

CRACKING OF LEFT PIER (Note Mildew On Pier)

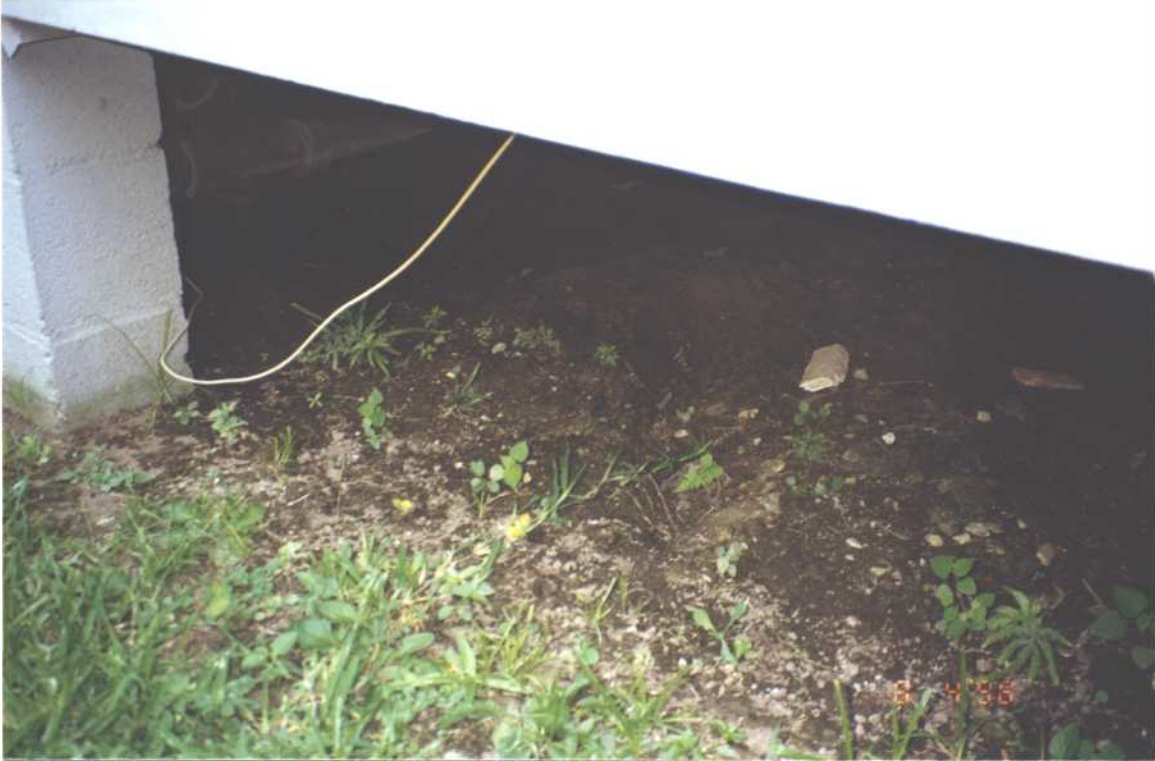
There are other factors which can cause additional settlement. These include, variations in the moisture content of the soil and vibrations. Some foundations, particularly those which are not on pilings and where the soil has a high clay content, may experience movement as the soil below the foundation expands or contracts due to changes in the water content of the soil. Numerous foundations in the Greater New Orleans area have experienced unanticipated movement during the extended period of dry weather which occurred in the summer and fall of last year and the spring and summer of this year. The pattern of settlement suggests that the water standing under the house is probably a significant factor in the settlement of the foundation. Soils testing is necessary to determine the extent to which the dry weather and water standing under the house may have contributed to the differential settlement.

WET AREA ON LEFT SIDE (Note Mildew On Pier)

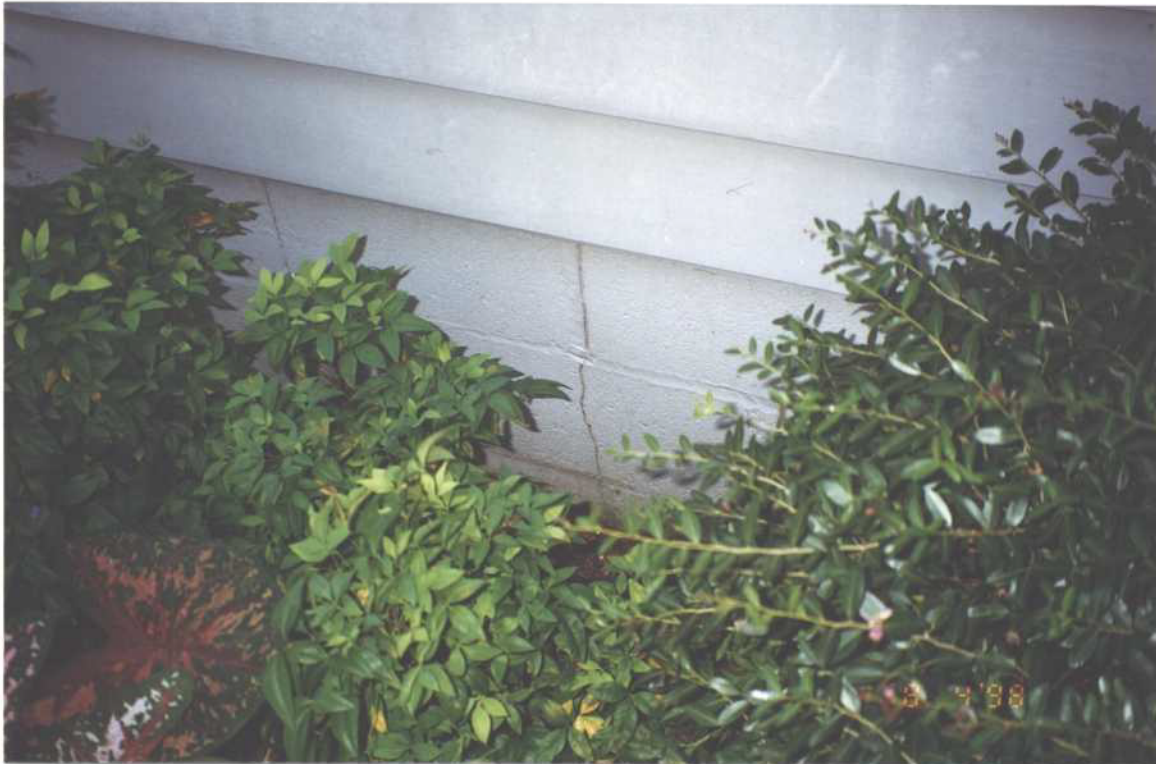
CRACKING OF CONCRETE BLOCK CHAINWALL

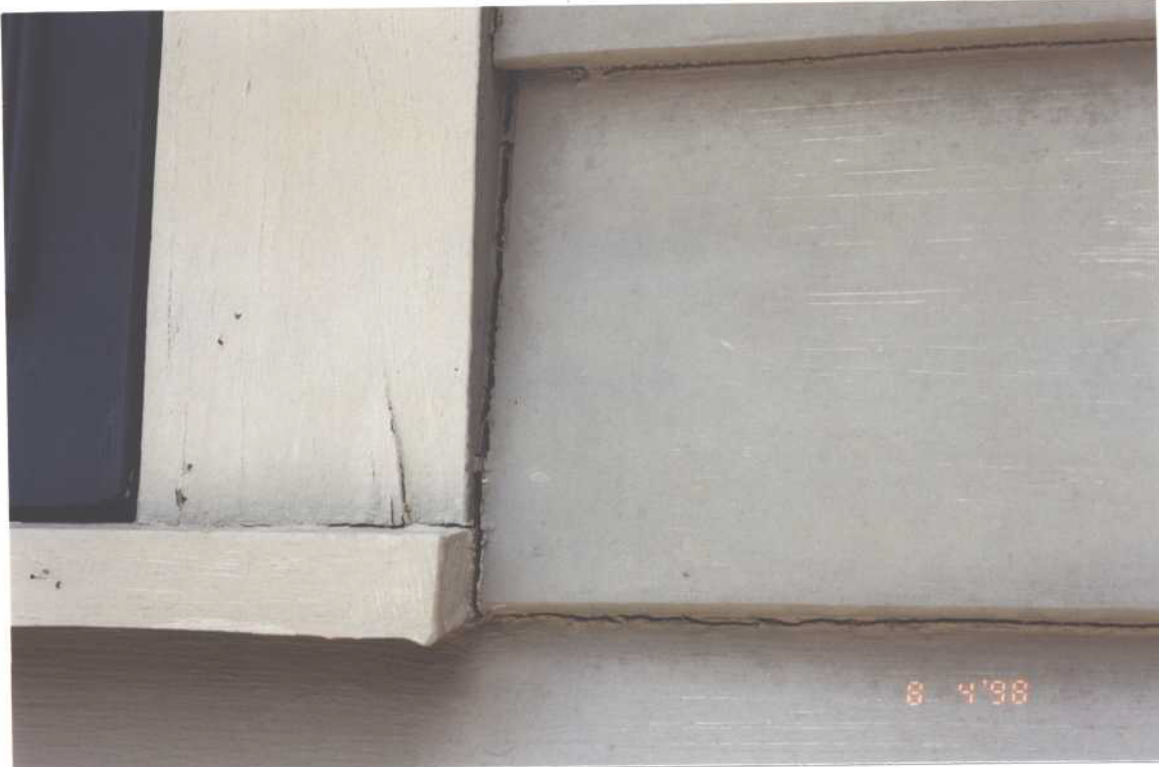
The exterior walls are in generally satisfactory condition. There are several gaps at the joints of the wood siding and trim. The gaps appear to have developed since the building was painted.

GAPS IN SIDING

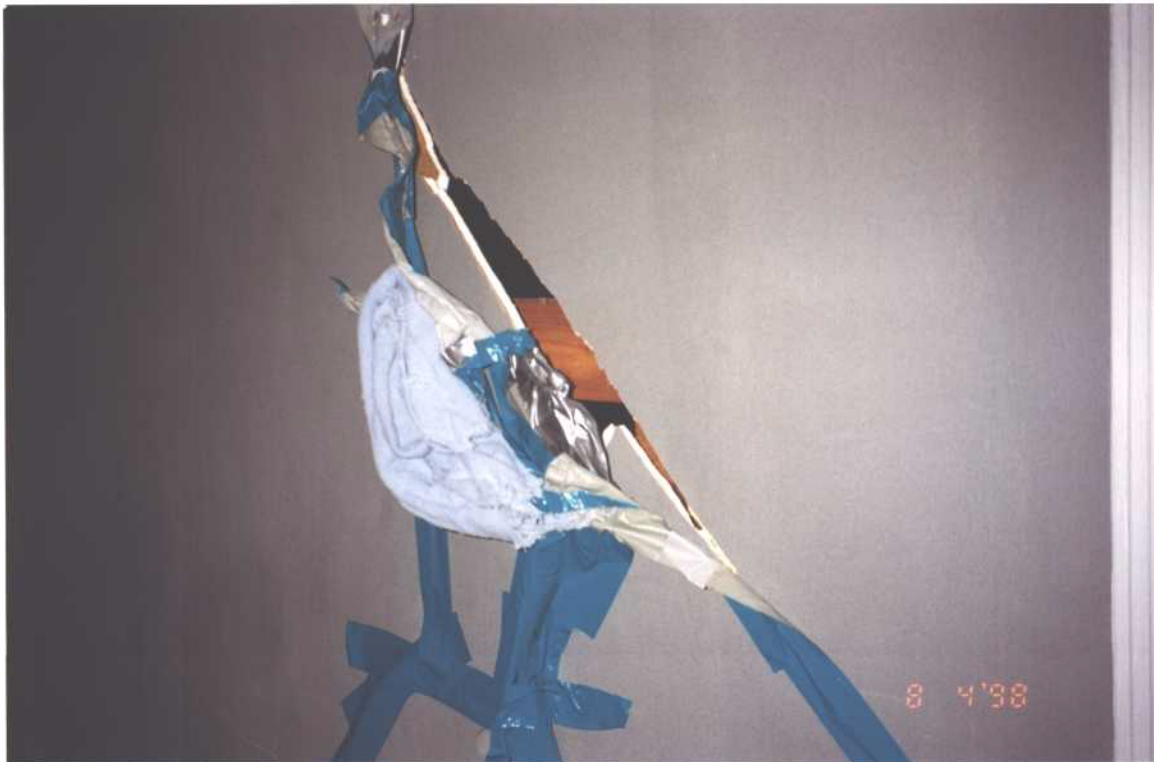
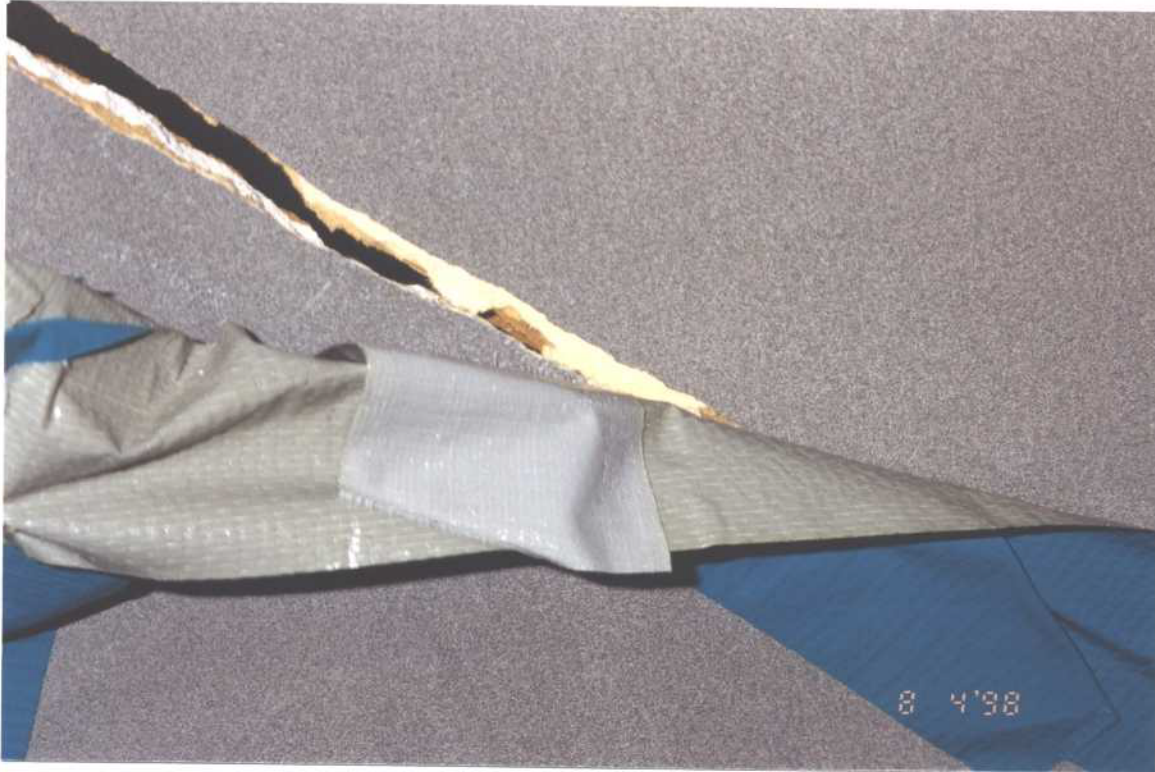
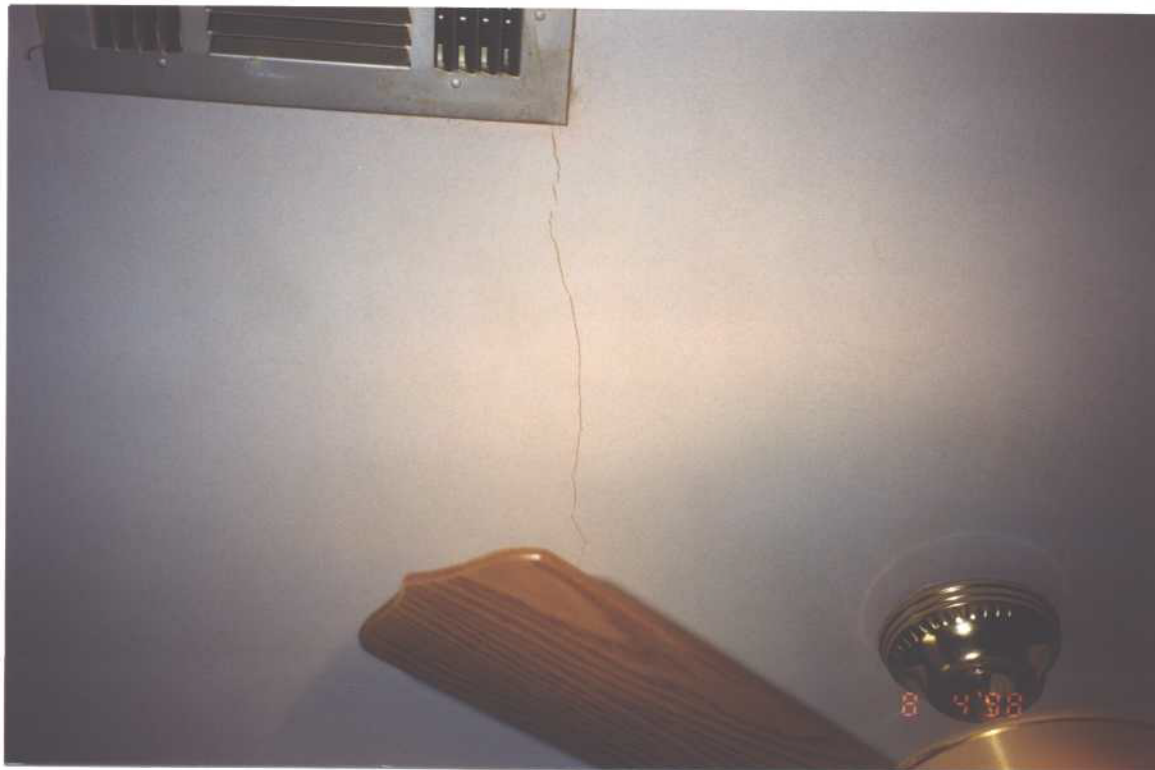
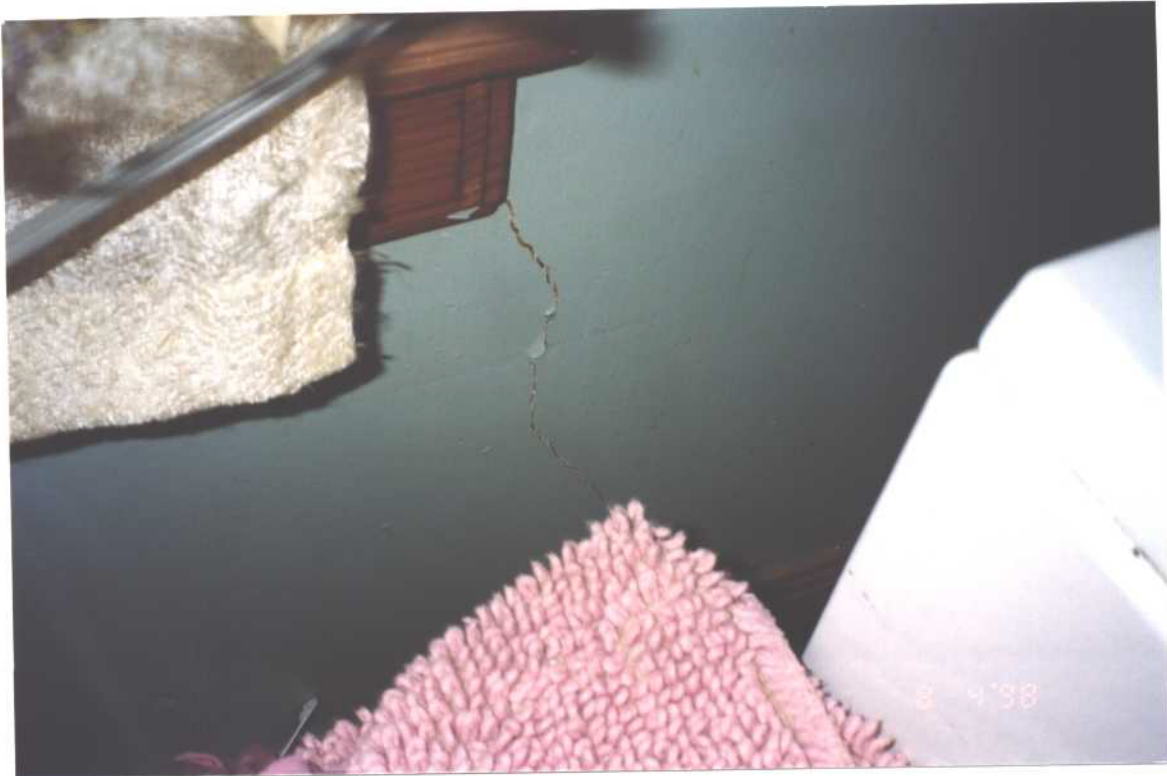
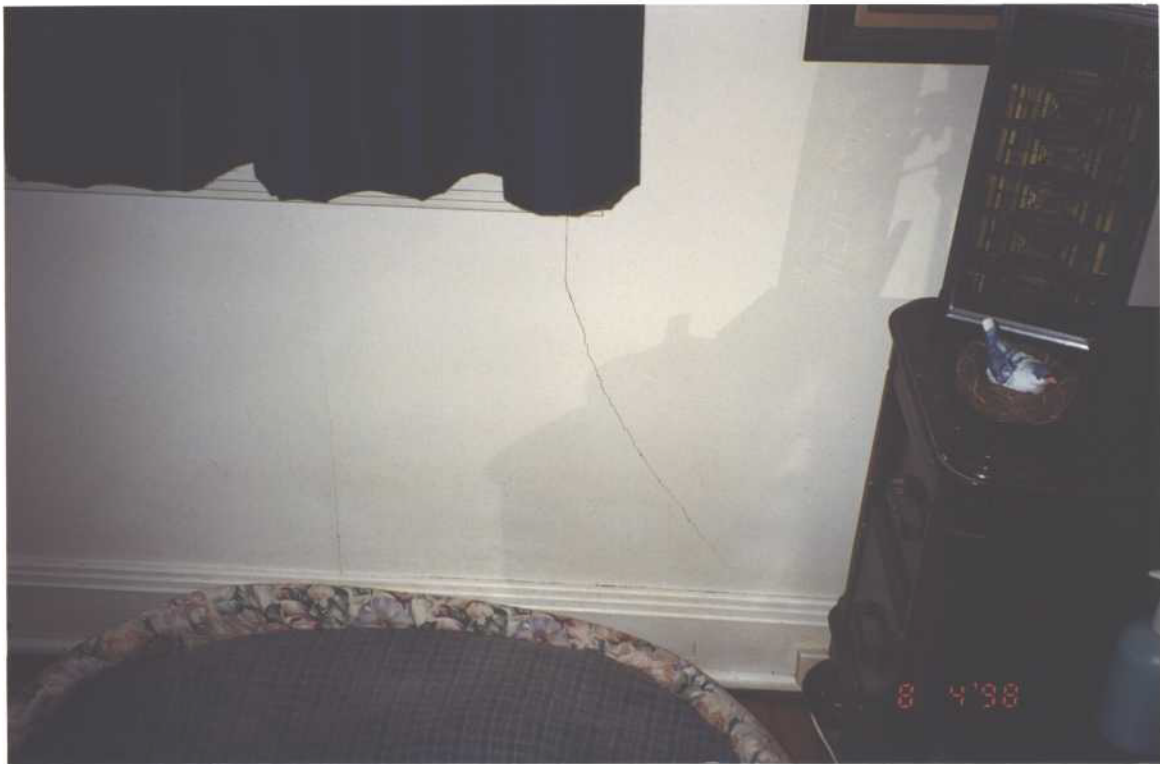
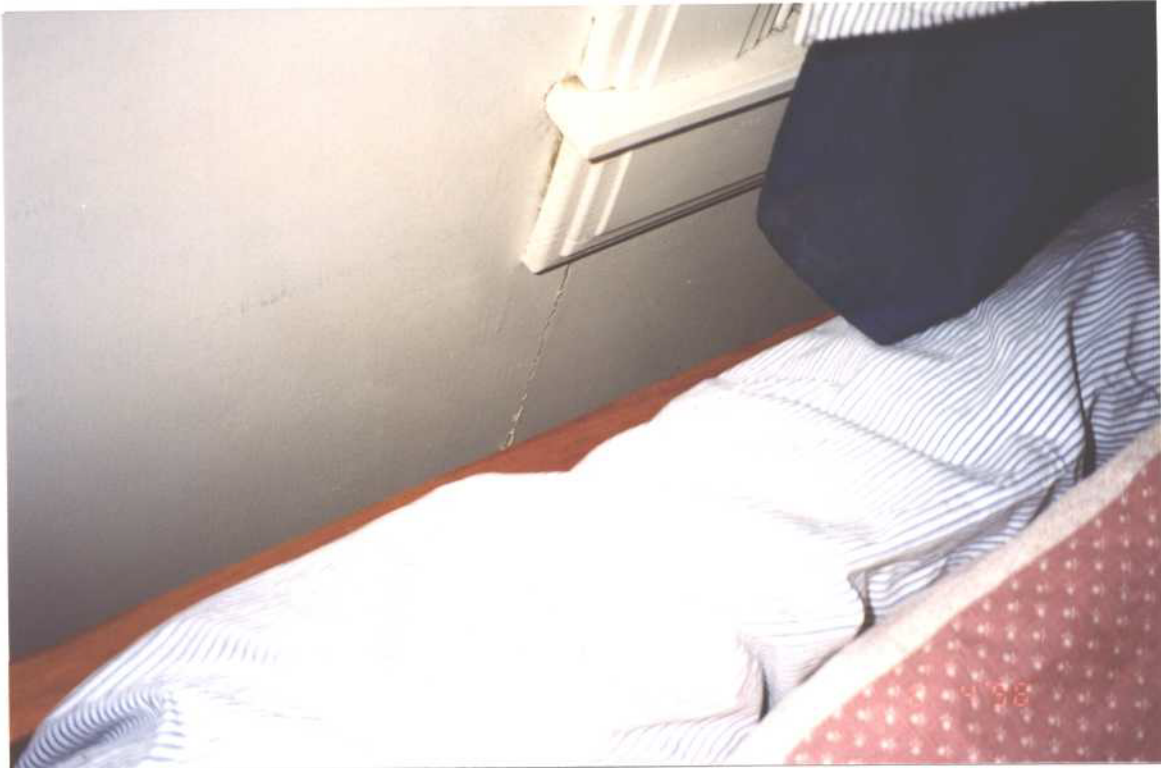
There is extensive cracking of the interior sheetrock. The most severe cracking is along the right side.

The amount of cosmetic damage is significantly higher than would normally be associated with this amount of settlement. This appears to be due primarily to the age of the building and the pattern of settlement (i.e. significant changes in relatively short distance.)

INTERIOR CRACKING
